WORLD SAILING INVESTIGATION REPORT NACRA 17 INCIDENT

World Sailing Investigation Report

REVIEW OF NACRA 17 CLASS INCIDENT WITH SEVERE INJURY TO HAND

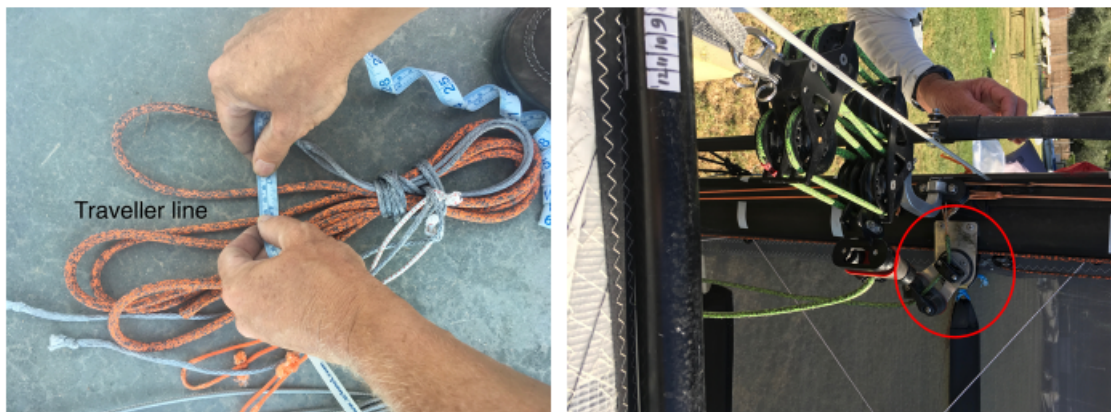
- iv. The helm has identified the traveler line wrapped around his right hand as the mechanism of the injury. In watching the video it can be seen that the main is on centerline until second 0:55 of the video when it suddenly drops to leeward. The sailors are not visible at this angle but this tells us that the traveler line has come loose and we know both sailors are forward in the water.

Traveler Arrangement – 6mm control line

- a. Personal Safety Awareness – Wrapping lines around the hand should be discouraged. This lesson is taught in learn to sail and must be reinforced as the sailor's progress into higher performance boats.

- b. Personal Safety should inform the design of the boat's rigging and controls. Controls allowed in the class rules should have sufficient purchase to allow a high-performance sailor to hold the line without wrapping it around a hand. It is beyond the scope of this investigation to assign that force.

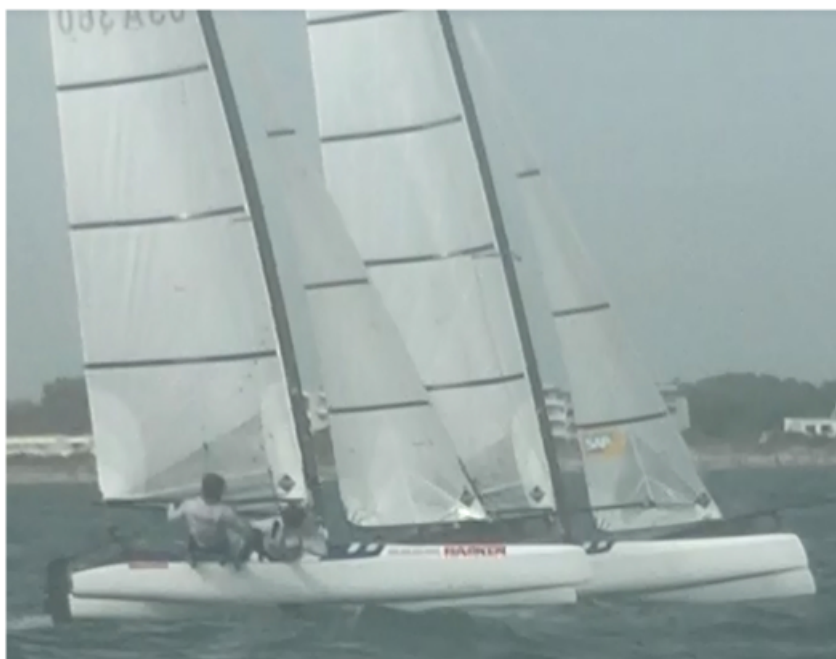
Figure D1 - Prior to Windward Mark

Accident occurred at the bear away after rounding the windward mark, as the boat turns at the offset mark.

Pictured:
Approaching the Windward Mark –
Note sailors positions, trapezing side by side with crew straddling the Shroud.

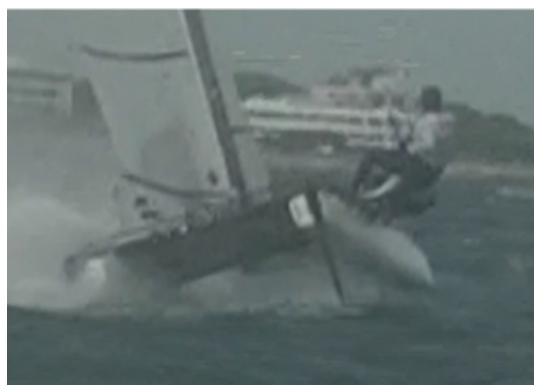
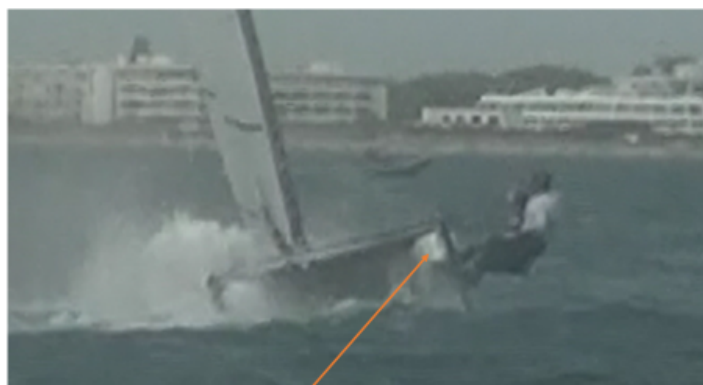
Figure D2 - Early in the Pitchpole

Bearing away and going bow down

Both sailors still standing on side of hull, not under hull

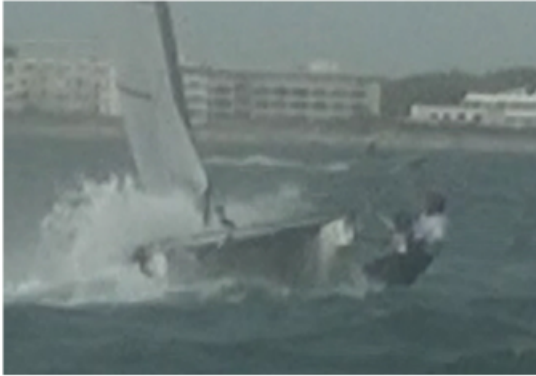
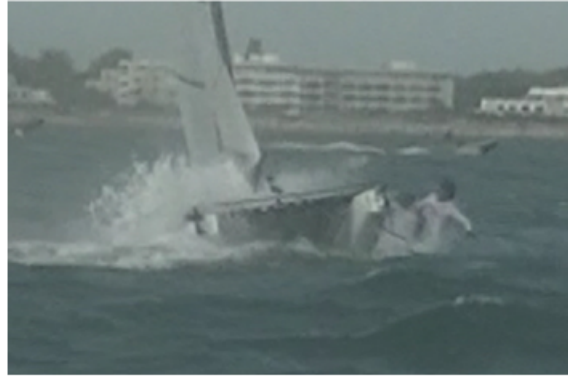
Figure D3 - Next Frames

Sailors still above the water, far away from hull

Looks like skipper is now outside of crew

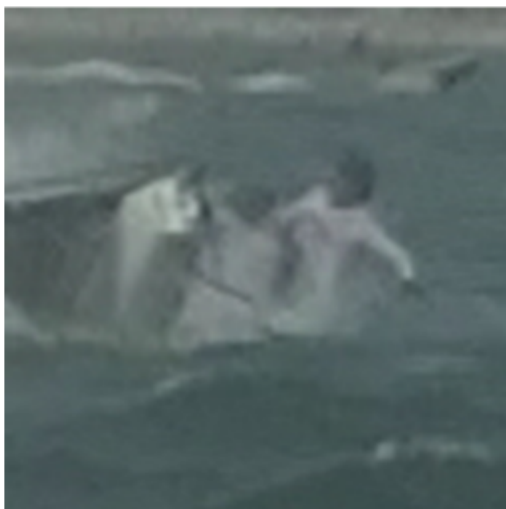
Figure D4 - Zoom In to See Helm's Position

The video is not clear enough for conclusive determination of what cut the sailor. The series of still frames taken from the video are over approximately one second of time.

1. Both sailors are well away from the daggerboard.
2. Both appear to be on their trapeze. Lines are not visible.
3. Helm's body is rotated with his back pointed forward and Crew appears inside the helm.

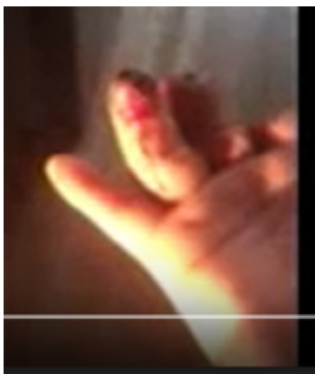
Figure D10 - Image of Right Hand After Amputation

These photos are approximately 3 weeks post injury. Note large abraded area of the ring finger. This finger was pinned By the Emergency Room Dr. Indicating that the finger was Broken during the accident.

- c. Personal Safety Equipment – Sailors should wear gloves that protect against cutting by thin lines and wire under load. These are commercially available at low cost. The standard these types of gloves are tested is based on cutting with a straight edge. There are no protection standards that apply to wrapping lines around a hand.
